Manhole Inspection Summary

Manhole # S45G__016MH

Insp Date: **3/12/09 11:05 AM**

Location Address: **203 s washington st**

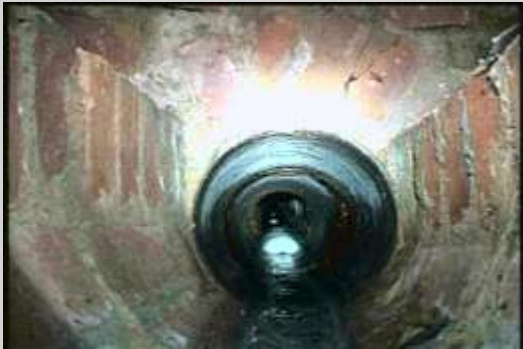
12 O'Clock Outflow

8 in. Circular Gravity Sewer
Pipe Out @ 12 OClock

Invert Depth: 11.00 (ft.) Flow Characteristics: Fast

Infiltration: None Pipe Seal Cond: Unknown

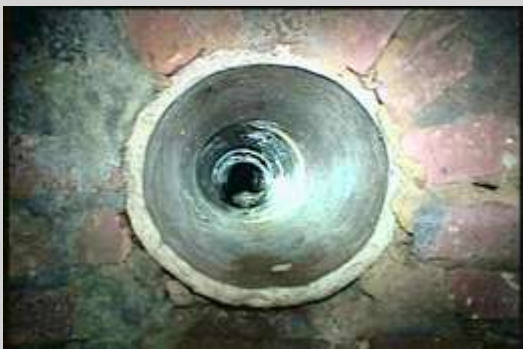
6 O'Clock Inflow

8 in. Circular Gravity Sewer
Pipe In @ 6 OClock

Invert Depth: 7.88 (ft.) Flow Characteristics: Fast

Infiltration: None Pipe Seal Cond: Unknown

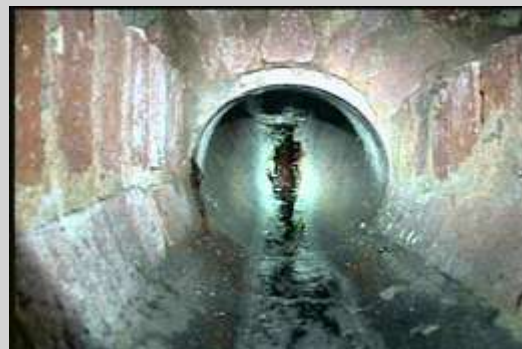
Drop In @ 6 OClock

Drop: Outside Direct

Drop Condition: Open
